## Inspection Report

**LDG Home Inspection, LLC**

<b>Date:</b> 12/27/2019	<b>Time:</b> 10:00 AM	<b>Report ID:</b> LJD1994
<b>Property:</b> [REDACTED]	<b>Customer:</b> [REDACTED]	<b>Real Estate Professional:</b> [REDACTED]

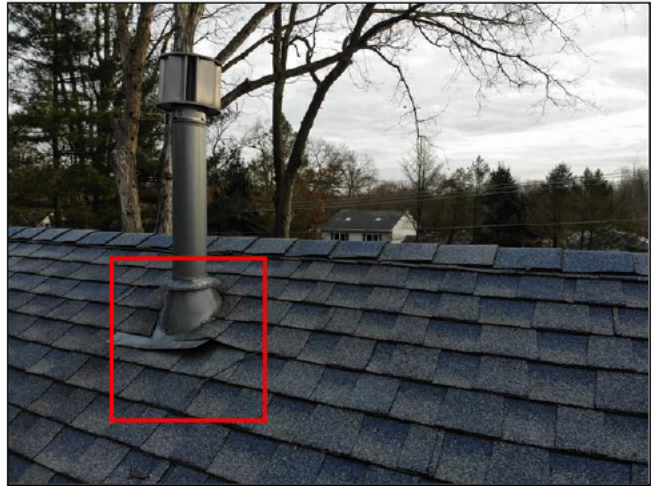
1.2 (1) Flashing is not properly seated around the furnace flue located on the rear roof of the main home. This can cause moisture intrusion which can damage the underlying structure. This should be repaired by a qualified contractor.

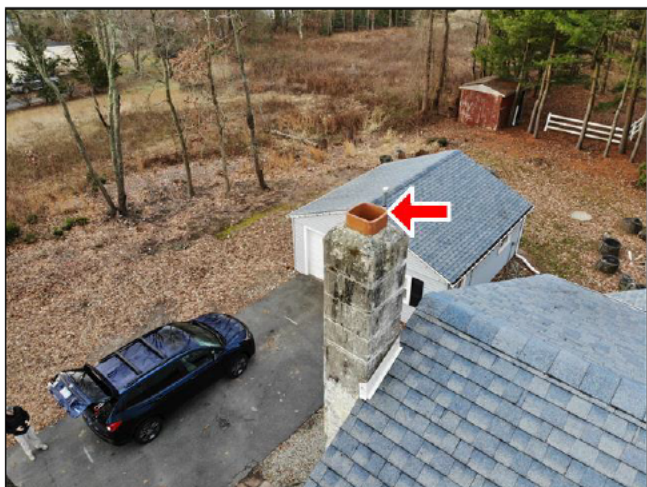
1.2 (2) The chimney(s) had no spark arrestor/weather cap. The Inspector recommends that all chimneys have an approved spark arrestor/weather cap installed by a qualified contractor to prevent pest entry and to help protect the roof-covering materials from potential chimney-source ignition.

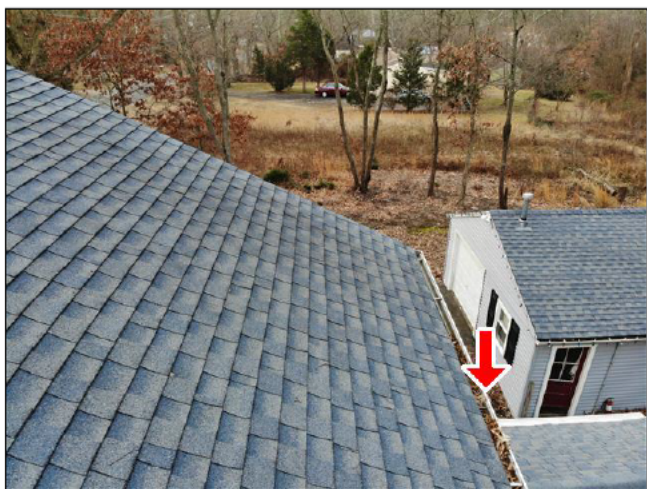
1.3 Debris visible in the gutters at the time of the inspection should be removed to encourage proper drainage.

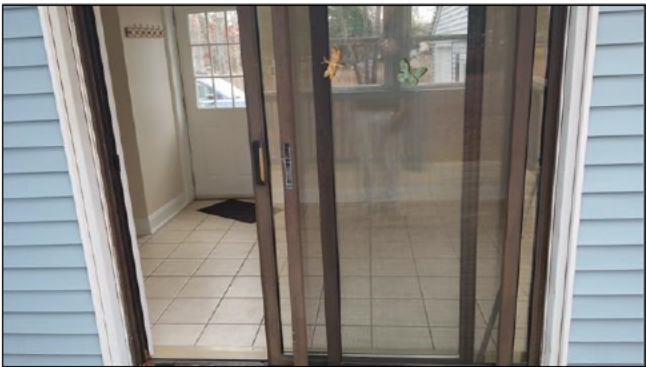
2.1 Exterior sliding door at rear of home was difficult to operate this is for your information.

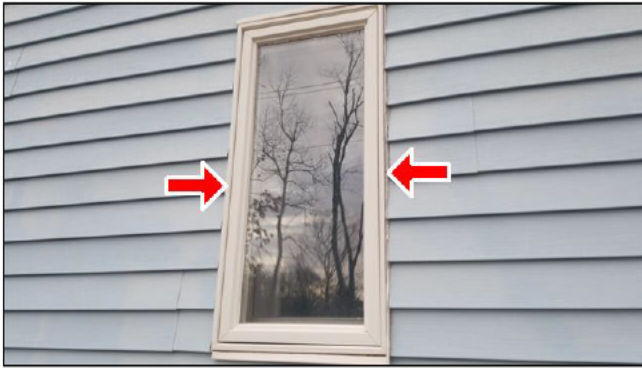
2.2 left side (facing front)&#160;

**2.2** Windows around the exterior of the home were caulked. Caulking usually breaks down over time and can result in moisture intrusion affecting the underlying structure and interior. It is recommended that all windows be maintained on a periodic basis to prevent deterioration. This is a maintenance issue and is for your information.

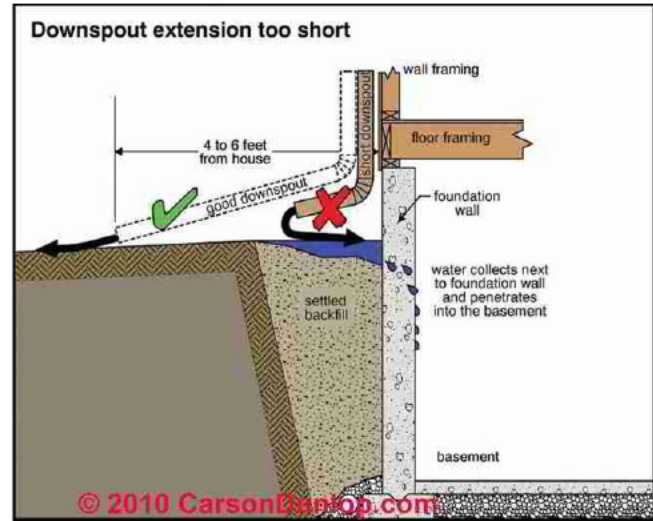
2.4 Downspout Extension

**2.4 (3)** One or more downspouts discharged roof drainage next to the foundation. This condition can effect the ability of the soil to support the weight of the structure above and can cause damage related to soil/foundation movement. The Inspector recommends the installation of downspout extensions to discharge roof drainage a minimum of 6 feet from the foundation.

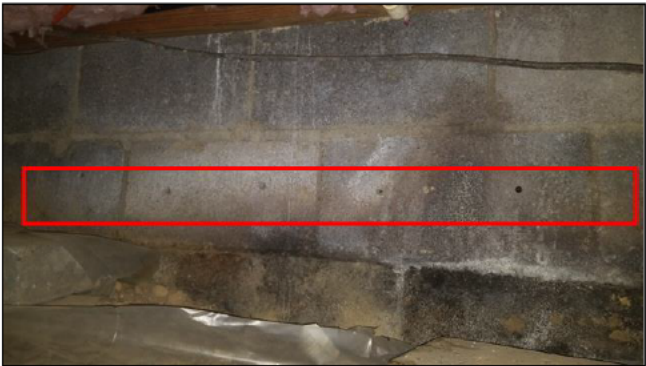
5.0 Evidence of previous termite treatment where bait was inserted into the concrete block. Recommend treatment for Wood Destroying Insects (WDI) by a qualified contractor.

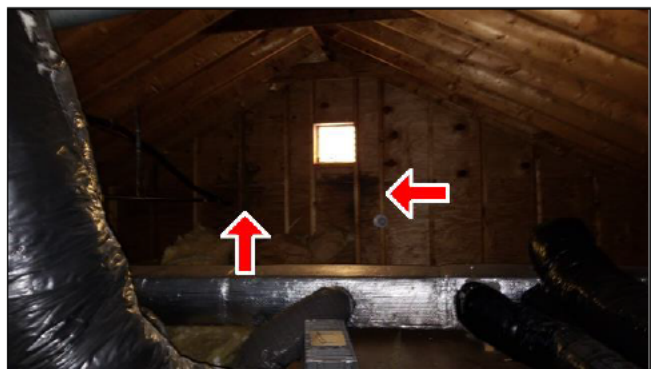
5.5 Gable end sheathing had areas of discoloration near the eaves. This may be due to a prior or active leak or the discoloration may be due to condensation. The inspector recommends that the sheathing be further evaluated by a qualified contractor who can recommend a solution to avoid further deterioration.

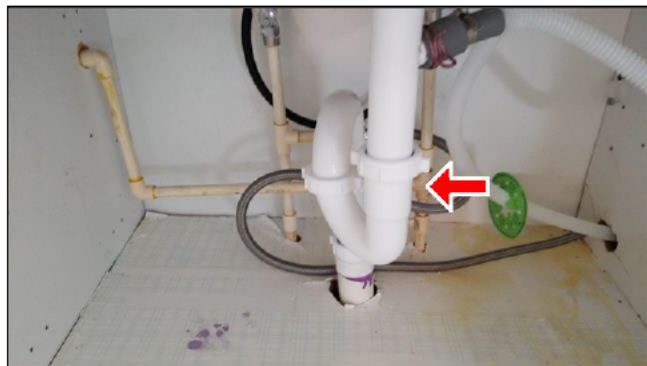
6.0 Kitchen

**6.0 (1)** A trap beneath a sink at the shown locations was of a type called an "S-trap". S-traps are no longer allowed to be installed in new construction for safety reasons. A siphon can develop which empties the trap of water; a condition with the potential to allow toxic sewer gas to enter the living space. Although this type of trap may have been commonly considered safe at the time the home was originally constructed, as general knowledge of safe building practices has improved with the passage of time, building standards have changed to reflect current understanding. The Inspector recommends replacement of all such traps in the home by a qualified plumbing contractor.

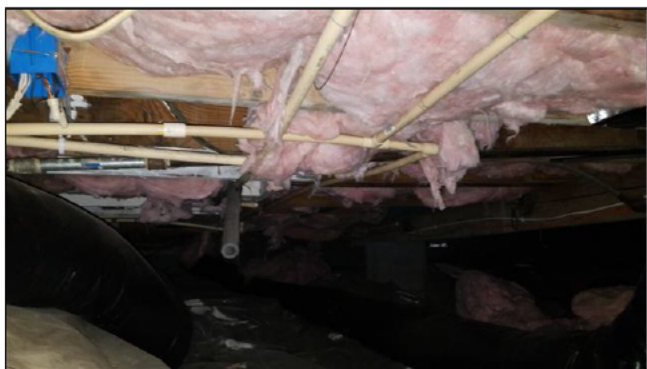
6.1

**6.1 (3)** Water distribution pipes in the Crawlspace are subject to damage from freezing temperatures. Freezing can cause pipes to burst and leak, with the potential for flooding and water damage to home materials. The Inspector recommends that action be taken to protect pipes from freezing

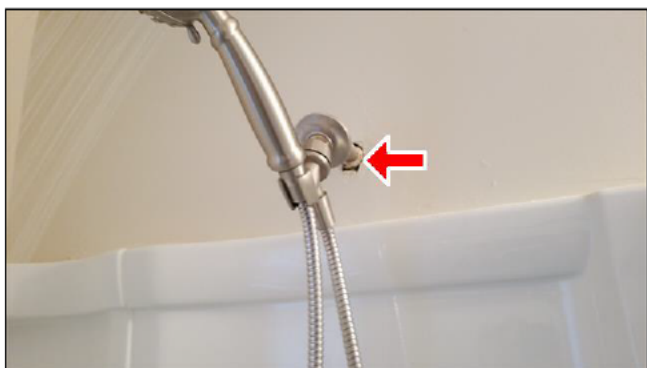
6.1

**6.1 (4)** Seal escutcheon plate in master bedroom shower to prevent moisture intrusion. All work should be performed by a licensed plumber.

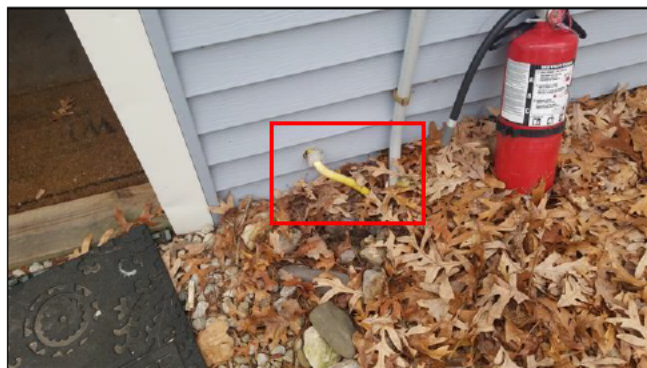
6.4 There is an exposed gas line on the exterior of the garage. It appears that this supplied gas to the previously installed garage heater. It does not appear that this line is In use but I am on able to determine. Recommend further evaluation by a licensed plumber to ensure that this line is properly abandoned.

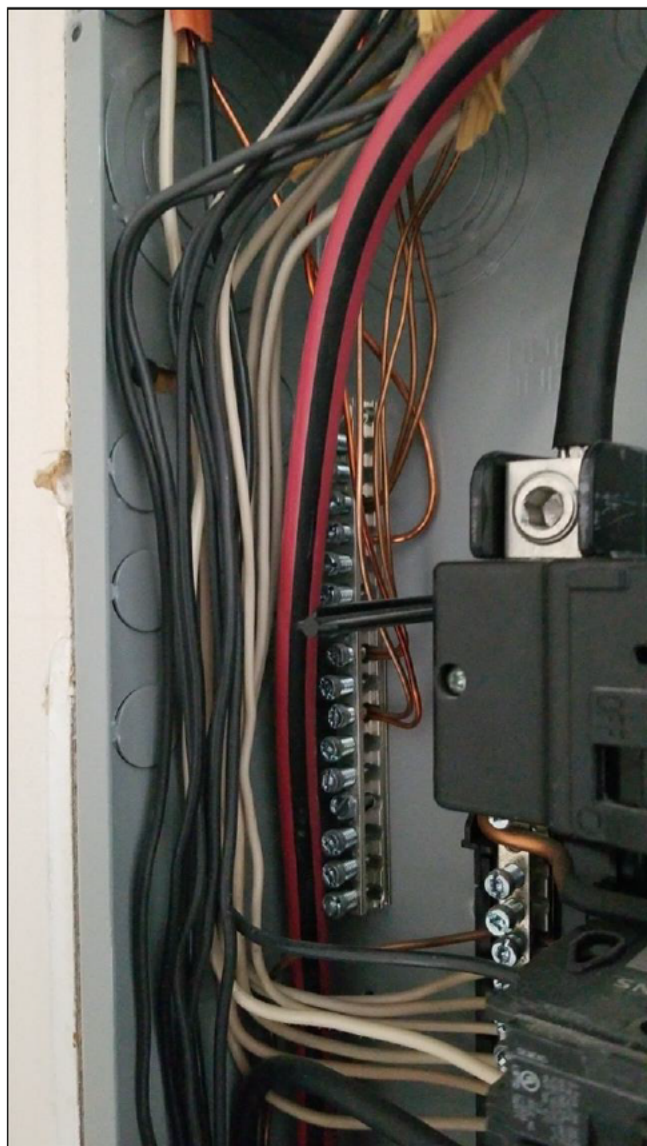
7.1 (2) For the main panel in the master bedroom, I could not locate the ground wire. The ground wire may not be present or could be hidden from view by construction materials. I recommend an electrical contractor verify or install a ground wire.

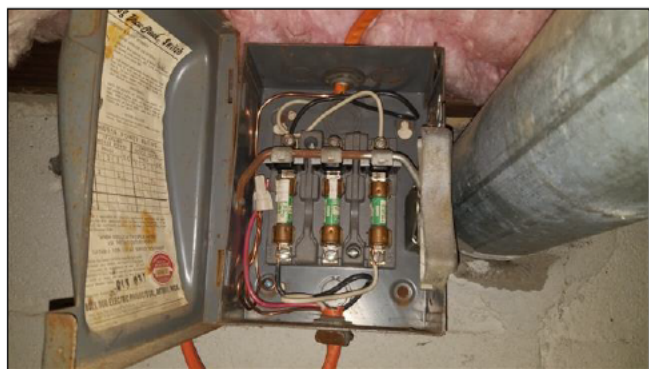
7.1 (4) There is a cartridge fuse subpanel in the crawlspace. This is outdated and replacement should be considered by a licensed electrician.

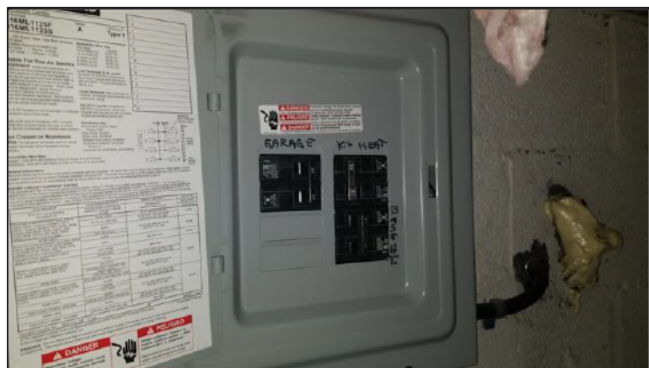
7.1 Siemens Subpanel in Crawlspace

The grounding bar should be properly secured as this is a hazard in its current state. All work should be performed by a licensed electrical contractor.

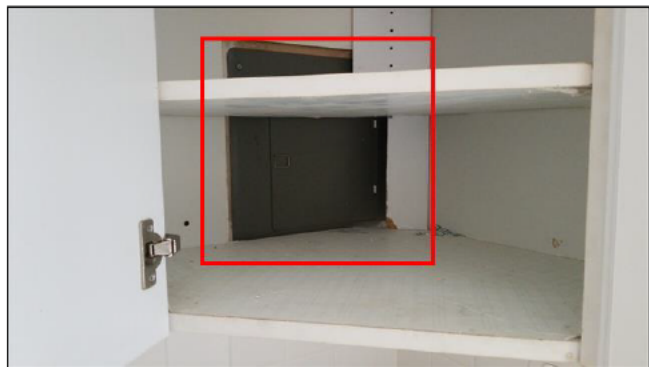
7.1

This panel cabinet had inadequate working clearance in front. Modern safety standards require a minimum open space 30 inches in width for a height of 6 feet-6 inches. Minimum clearance in front of the cabinet should be 3 feet. The Inspector recommends correction by a qualified contractor. See illustration for further detail.

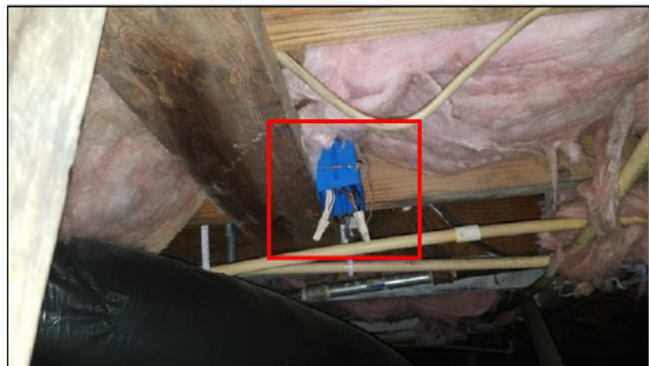
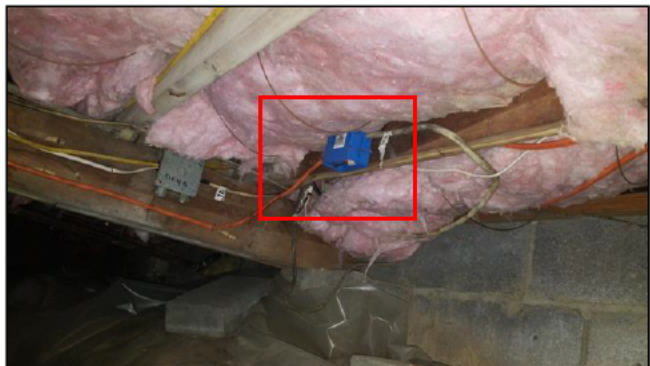
7.3 crawlspace

7.3 (1) An energized electric cable is exposed at the shown location. This is a hazard that can result in shock or electrocution. This should be properly encased. Please have this, as well as any other electrical deficiency observed in the crawlspace at the time of the repair, corrected by a licensed electrician.

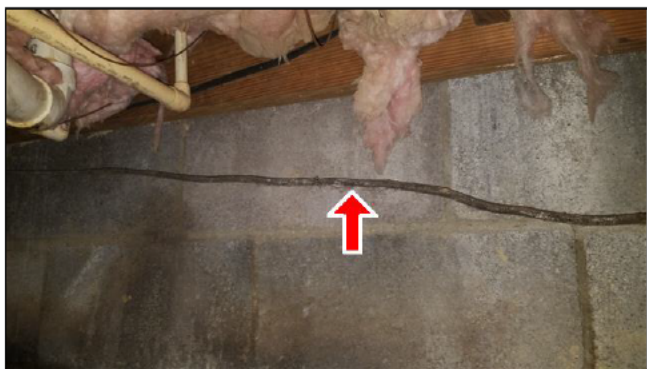
7.3 (2) Poorly supported wires visible in the crawlspace should be properly fastened. Safe building practices require branch conductors to be supported at intervals no greater than 4 feet-6 inches. The Inspector recommends correction by a qualified contractor.

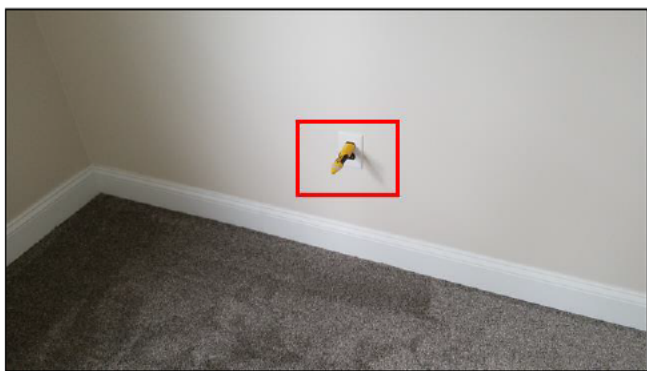
7.3 Rear master bedroom rear wall

7.3 (3) Shown outlets were not working at the time of inspection. Further inspection is needed by a licensed electrical contractor. A licensed electrical contractor should perform repairs that involve wiring.

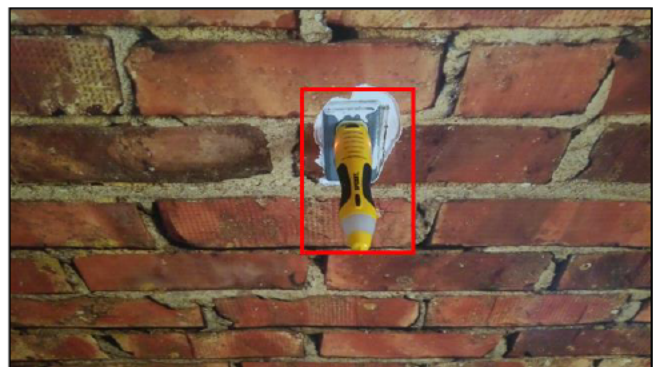
7.4 Garage

**7.4** (2) Multiple Garage receptacles have an open ground. This is a safety hazard and can cause shock or electrocution. Please have this corrected by a licensed electrician.

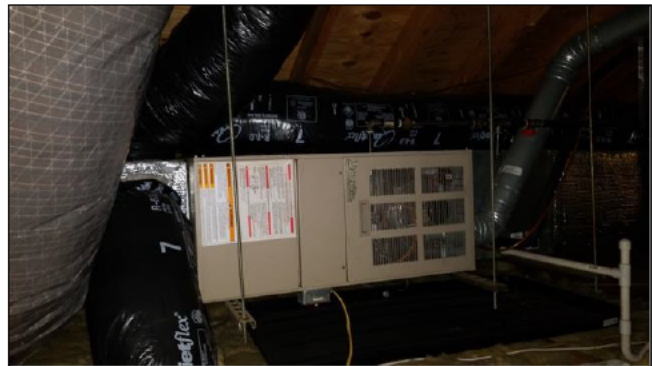
8.0 Ducane heater unit located in the Attic above second floor. The unit was manufactured in 2005 and is approximately 15 years old. Although the unit appeared to be in serviceable condition at the time of inspection, it is nearing the end of its expected design life and replacement may be required.

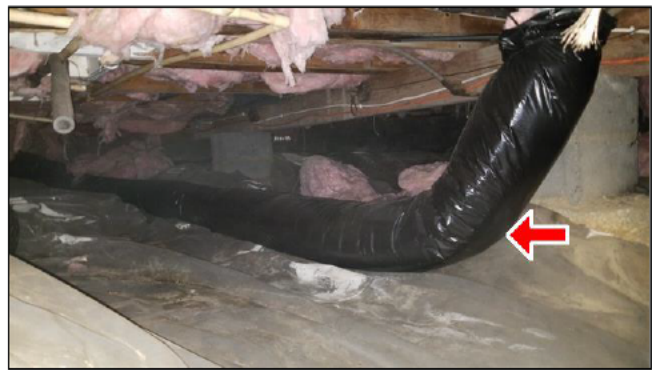
8.3 The plenum needs support straps in the crawlspace. Besides energy loss, damage to duct pipe is large enough to allow insects or critters to enter through ductwork. I recommend service or repair as needed.

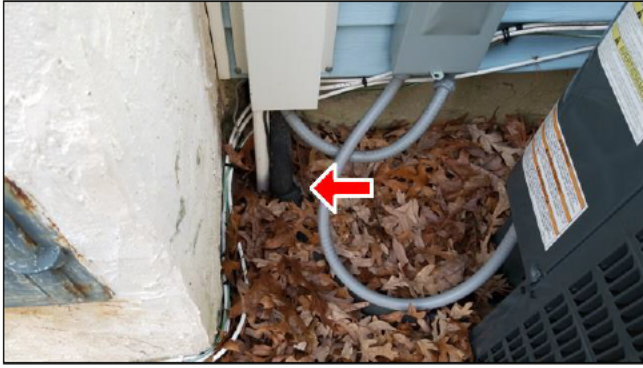
8.8

**8.8 (2)** Insulation on the air-conditioning suction (large, insulated) line was damaged or missing at areas and should be replaced by a licensed HVAC contractor.

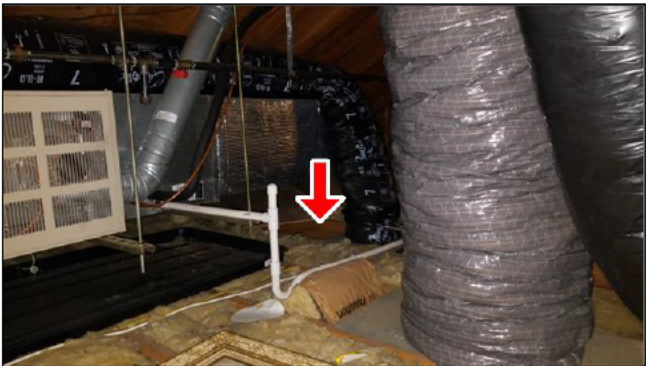
9.0 The attic was missing insulation in some areas. This condition can result in increased heating and cooling costs, reduced comfort levels and may contribute to ice damming of the roof during the winter. The Inspector recommends that insulation be properly distributed to cover all portions of the attic located above the home living space. All work should be performed by a qualified contractor

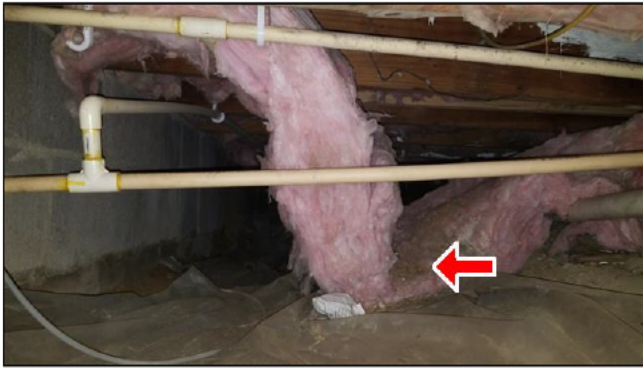
9.1

**9.1** The insulation is loose/fallen in the crawlspace. Insulation that has fallen to the ground or has become damp from the ground or from condensation usually needs to be replaced with new insulation. A qualified person should repair or replace as needed.

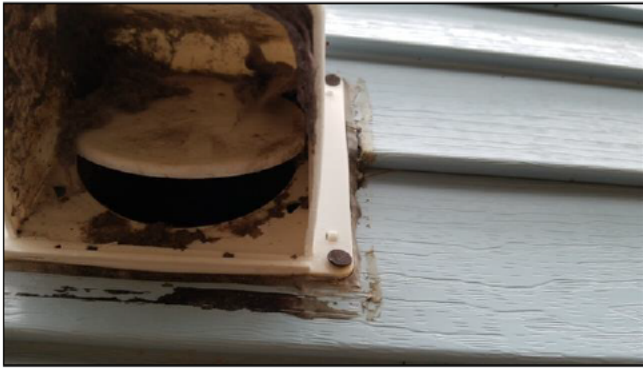
9.4

**9.4** The dryer vent should be cleaned as build up of lint is visible and can cause a fire. Recommend this be done immediately and prior to use of the appliance.

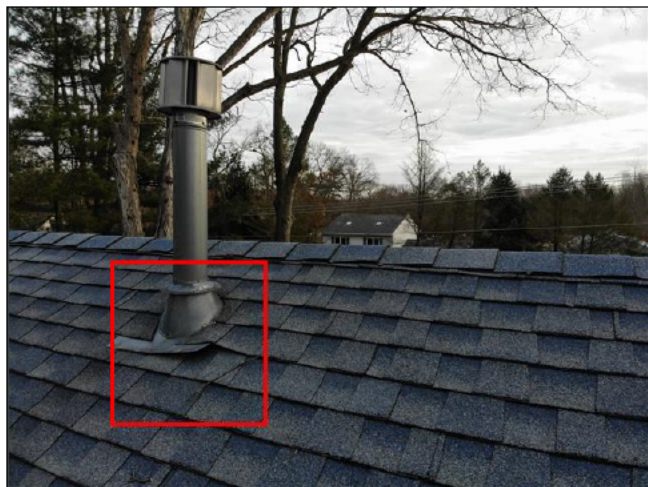
1.2

(1) Flashing is not properly seated around the furnace flue located on the rear roof of the main home. This can cause moisture intrusion which can damage the underlying structure. This should be repaired by a qualified contractor.

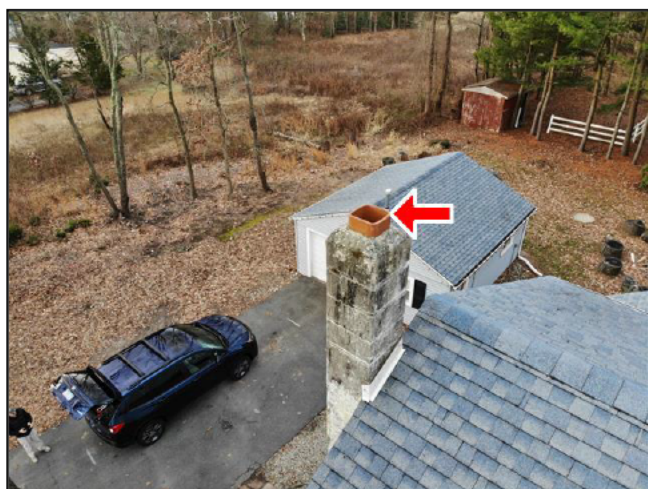
1.2

(2) The chimney(s) had no spark arrestor/weather cap. The Inspector recommends that all chimneys have an approved spark arrestor/weather cap installed by a qualified contractor to prevent pest entry and to help protect the roof-covering materials from potential chimney-source ignition.

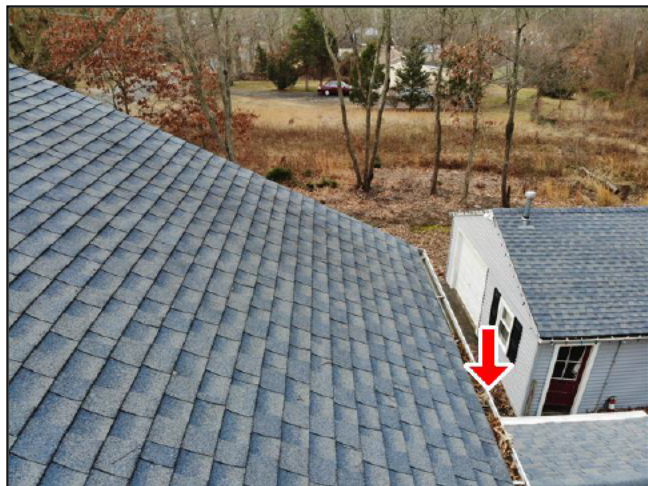
1.3

Debris visible in the gutters at the time of the inspection should be removed to encourage proper drainage.

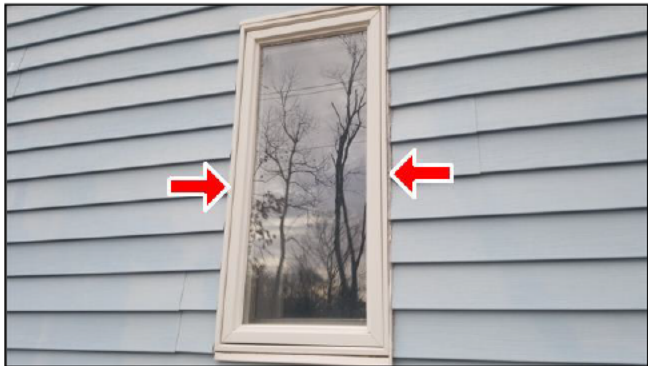
2.2 left side (facing front)&#160;

Windows around the exterior of the home were caulked. Caulking usually breaks down over time and can result in moisture intrusion effecting the underlying structure and interior. It is recommend that all windows be maintained on a periodic basis to prevent deterioration. This is a maintenance issue and is for your information.

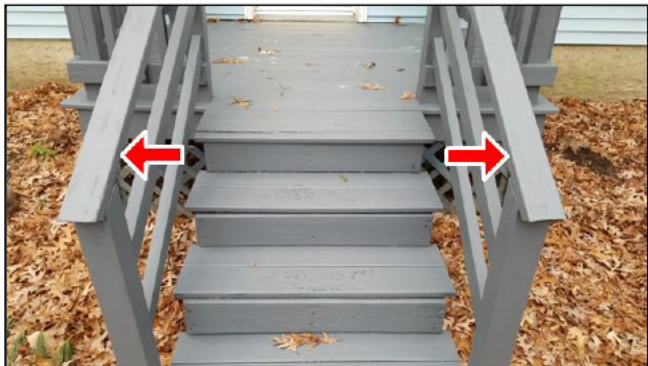
2.3

(1) This staircase at front of home did not meet generally-accepted modern safety standards that specify the proper the size and dimensions of a grippable handrail. It is recommended that one be installed by a qualified contractor.

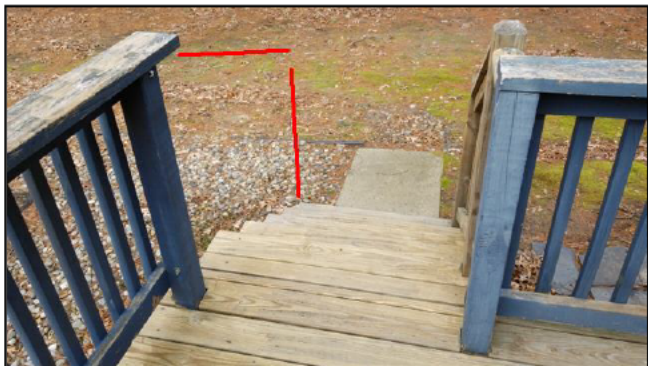
2.3 rear of home

(2) The inspector recommends installation of both a guardrail and graspable handrail at the Rear Deck Steps. This is considered a safety hazard as someone can fall from the landing and be injured. Recommend that all work be performed by a qualified contractor.

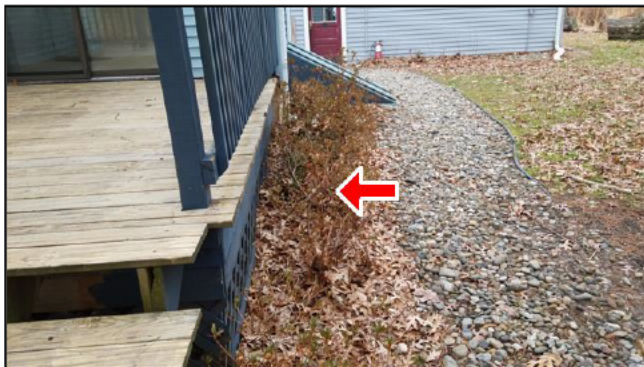
2.4

(2) Shrubs have been constructed near the exterior walls. Water for plants/shrubs will eventually soak into soil and may reach soil supporting the foundation. Excessively high moisture levels in soil supporting the foundation can effect its ability to support the weight of the structure above. The Inspector recommends removal of any shrubbery or plants near the foundation or re-planting with vegetation which has low water requirements.

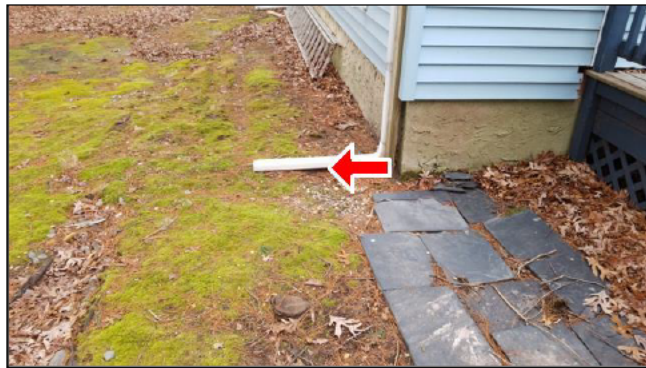
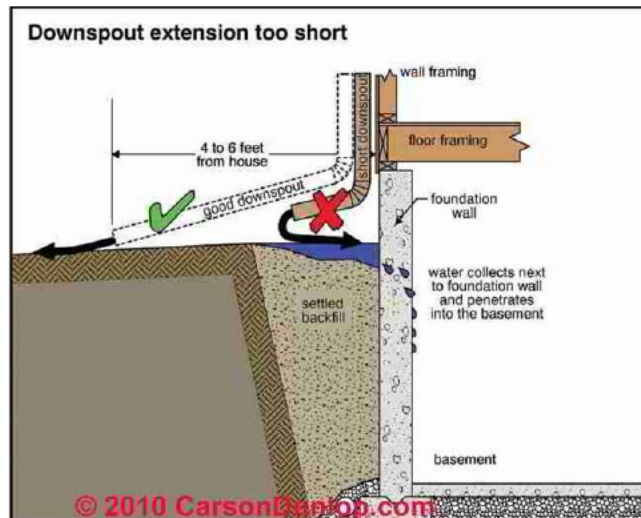
2.4

(3) One or more downspouts discharged roof drainage next to the foundation. This condition can effect the ability of the soil to support the weight of the structure above and can cause damage related to soil/foundation movement. The Inspector recommends the installation of downspout extensions to discharge roof drainage a minimum of 6 feet from the foundation.

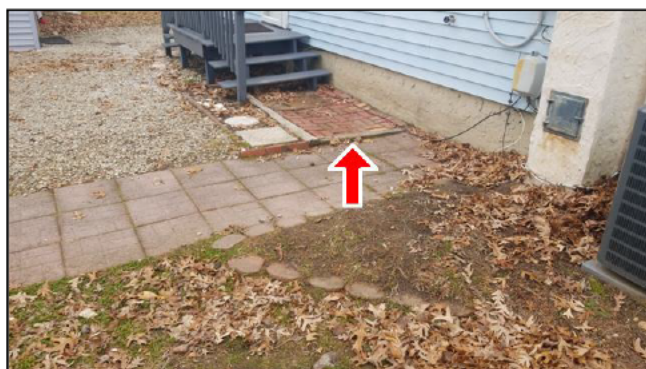
2.4

(4) The concrete walkway at the front of home uneven, and can be a tripping hazard. A fall or injury can occur if not corrected. A qualified person should repair or replace as needed.

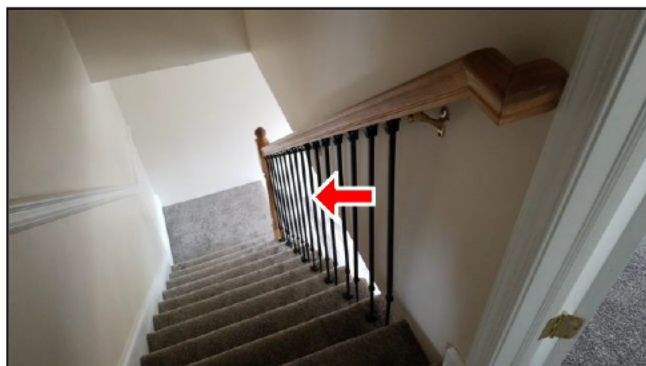
4.3

A horizontal guardrail assembly protecting this stairwell had spaces between handrail components that allowed the passage of a 4-inch sphere. To improve child safety, the Inspector recommends altering the guardrail assembly in a manner which will prevent the passage of a 4-inch sphere. This dimension includes areas beneath and to the sides of the guardrail. The Inspector recommends that this condition be updated to meet generally-accepted modern safety standards by a qualified contractor.

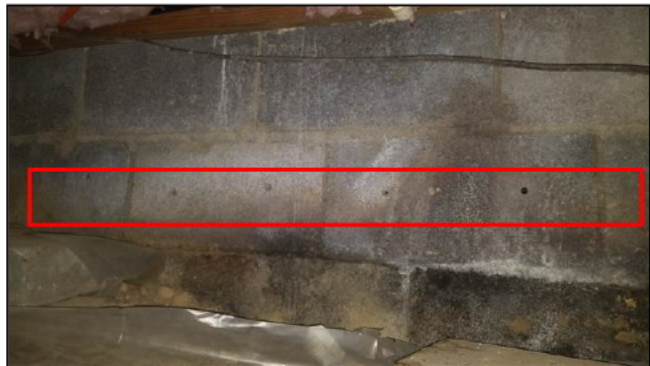
5.0

Evidence of previous termite treatment where bait was inserted into the concrete block. Recommend treatment for Wood Destroying Insects (WDI) by a qualified contractor.

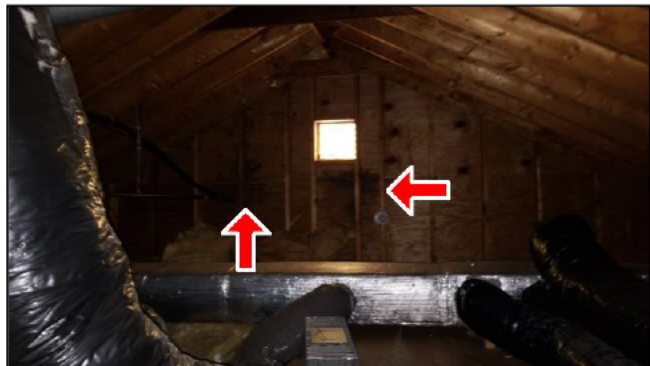
5.5

Gable end sheathing had areas of discoloration near the eaves. This may be due to a prior or active leak or the discoloration may be due to condensation. The inspector recommends that the sheathing be further evaluated by a qualified contractor who can recommend a solution to avoid further deterioration.

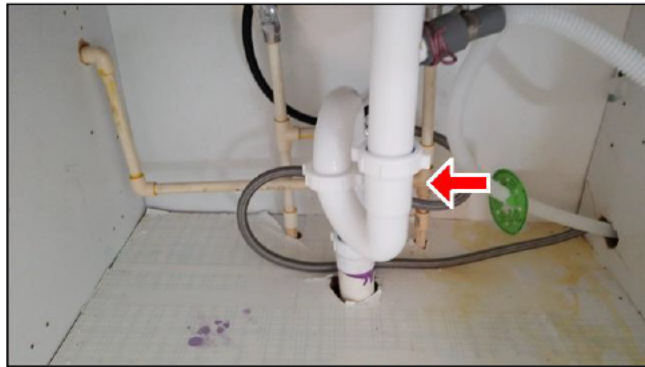
6.0 Kitchen

(1) A trap beneath a sink at the shown locations was of a type called an "S-trap". S-traps are no longer allowed to be installed in new construction for safety reasons. A siphon can develop which empties the trap of water; a condition with the potential to allow toxic sewer gas to enter the living space. Although this type of trap may have been commonly considered safe at the time the home was originally constructed, as general knowledge of safe building practices has improved with the passage of time, building standards have changed to reflect current understanding. The Inspector recommends replacement of all such traps in the home by a qualified plumbing contractor.

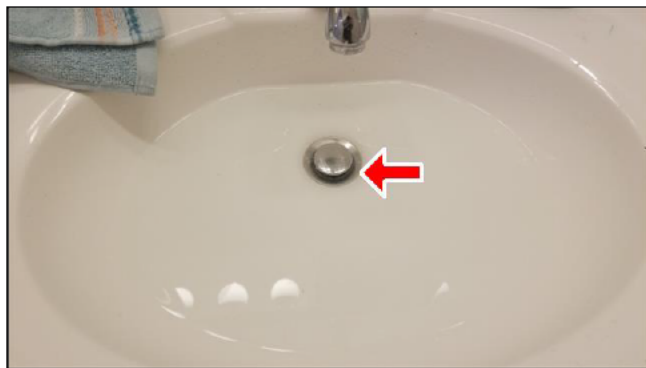
6.0 hall bath

(2) The sink in the powder room was slow to drain. This is typically due to a clogged trap but may also indicate a blockage of the waste pipe. You may wish to have this condition investigated by a licensed plumbing contractor.

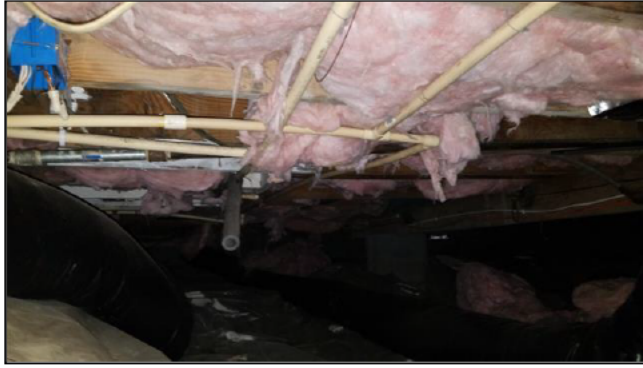
6.1

(3) Water distribution pipes in the Crawl space are subject to damage from freezing temperatures. Freezing can cause pipes to burst and leak, with the potential for flooding and water damage to home materials. The Inspector recommends that action be taken to protect pipes from freezing

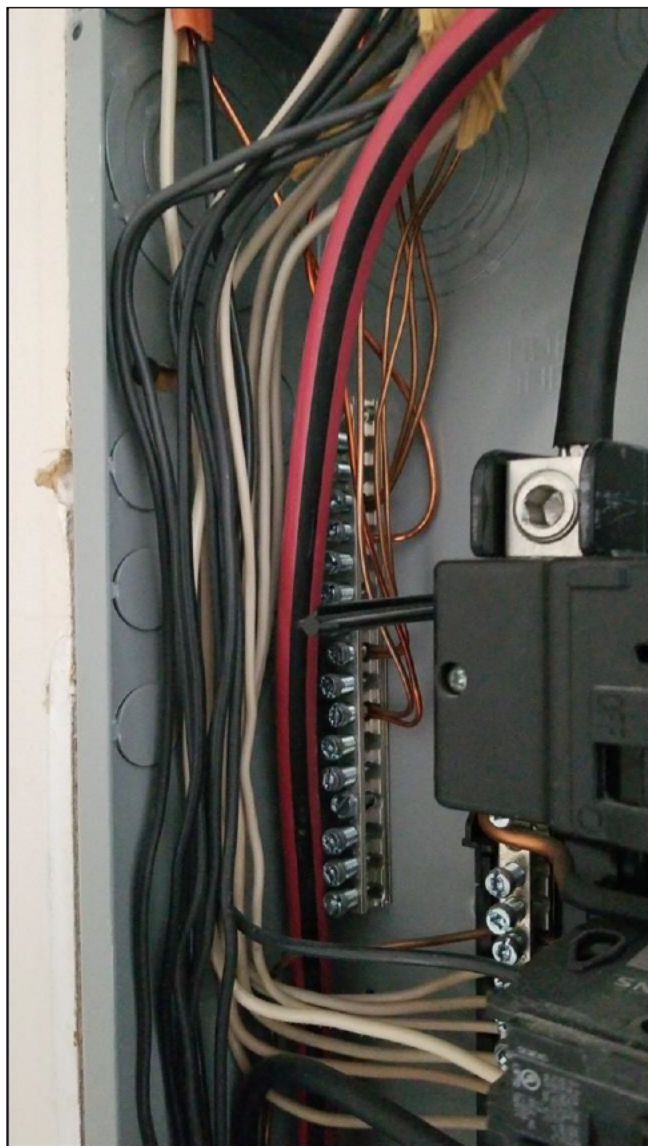
7.1

(2) For the main panel in the master bedroom, I could not locate the ground wire. The ground wire may not be present or could be hidden from view by construction materials. I recommend an electrical contractor verify or install a ground wire.

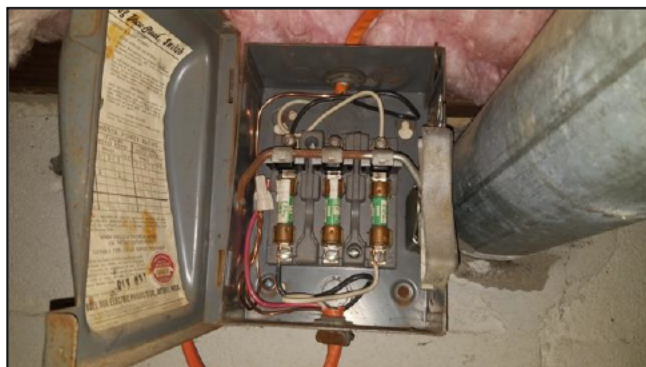
7.1

(4) There is a cartridge fuse subpanel in the crawlspace. This is outdated and replacement should be considered by a licensed electrician.

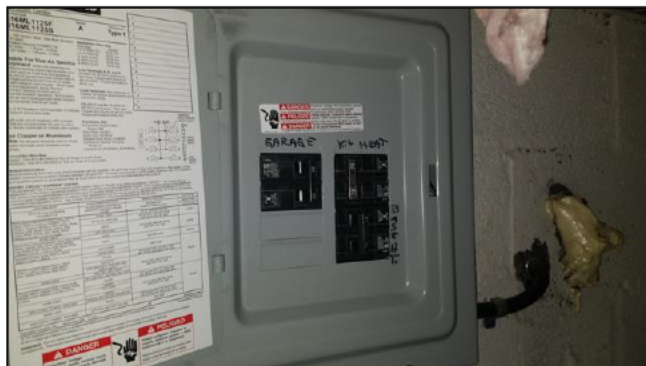
7.1 Siemens Subpanel in Crawlspace

The grounding bar should be properly secured as this is a hazard in its current state. All work should be performed by a licensed electrical contractor.

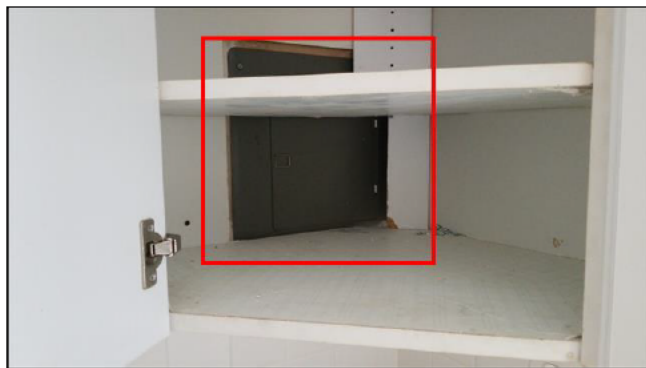
7.1

This panel cabinet had inadequate working clearance in front. Modern safety standards require a minimum open space 30 inches in width for a height of 6 feet-6 inches. Minimum clearance in front of the cabinet should be 3 feet. The Inspector recommends correction by a qualified contractor. See illustration for further detail.

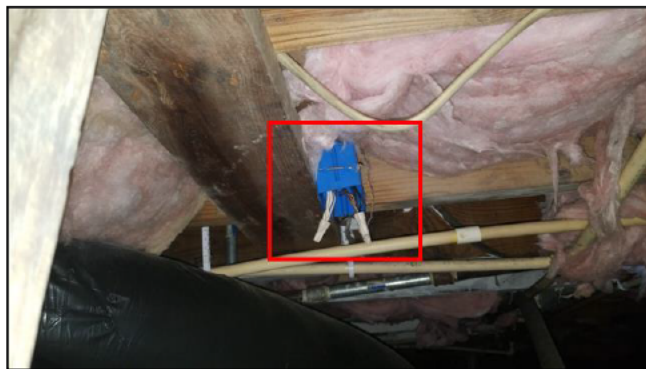
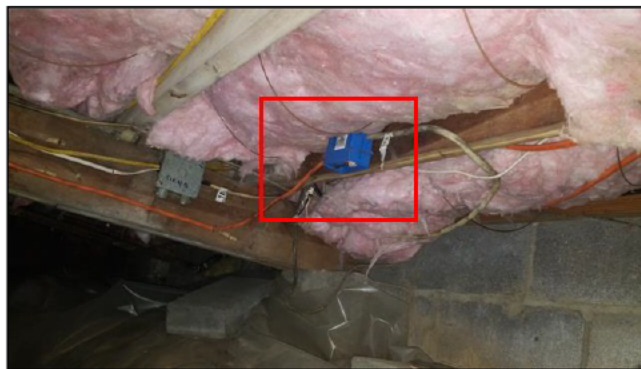
7.3 crawlspace

(1) An energized electric cable is exposed at the shown location. This is a hazard that can result in shock or electrocution. This should be properly encased. Please have this, as well as any other electrical deficiency observed in the crawlspace at the time of the repair, corrected by a licensed electrician.

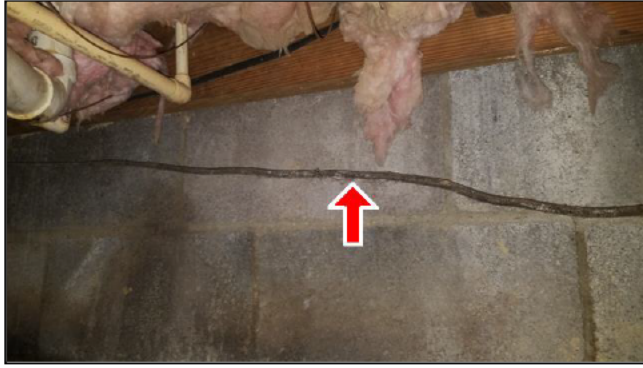
7.3

(2) Poorly supported wires visible in the crawlspace should be properly fastened. Safe building practices require branch conductors to be supported at intervals no greater than 4 feet-6 inches. The Inspector recommends correction by a qualified contractor.

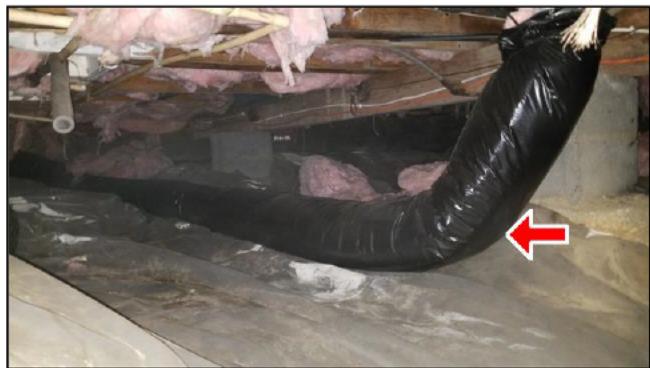
8.3

The plenum needs support straps in the crawlspace. Besides energy loss, damage to duct pipe is large enough to allow insects or critters to enter through ductwork. I recommend service or repair as needed.

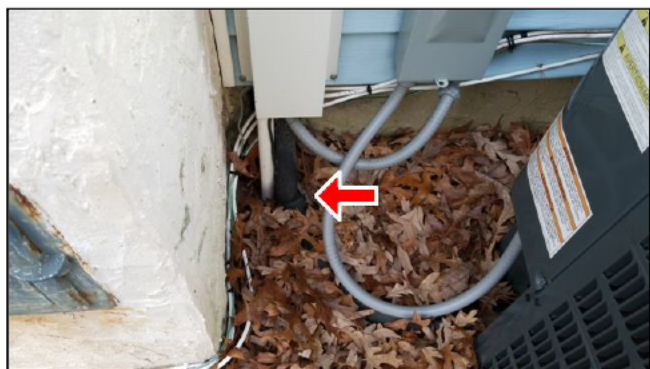
8.8

(2) Insulation on the air-conditioning suction (large, insulated) line was damaged or missing at areas and should be replaced by a licensed HVAC contractor.
