## Inspection Report

**LDG Home Inspection, LLC**

<b>Date:</b> 12/27/2019	<b>Time:</b> 10:00 AM	<b>Report ID:</b> LJD1994
<b>Property:</b> [REDACTED]	<b>Customer:</b> [REDACTED]	<b>Real Estate Professional:</b> [REDACTED]

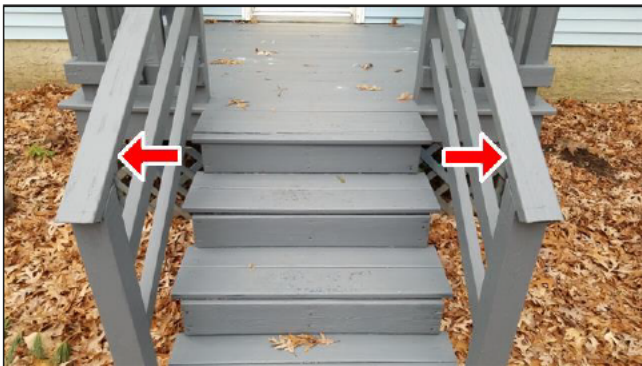
2.3

**2.3 (1)** This staircase at front of home did not meet generally-accepted modern safety standards that specify the proper the size and dimensions of a grippable handrail. It is recommended that one be installed by a qualified contractor.

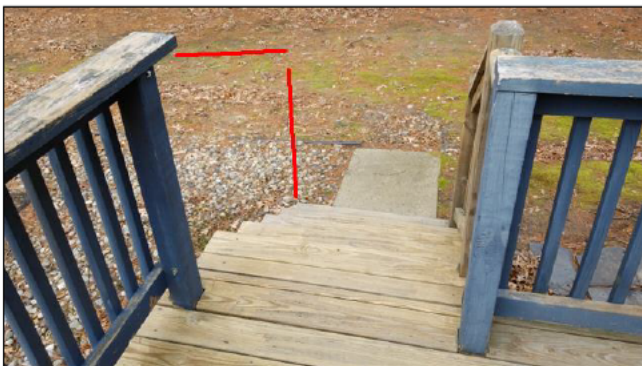
2.3 rear of home

**2.3 (2)** The inspector recommends installation of both a guardrail and graspable handrail at the Rear Deck Steps. This is considered a safety hazard as someone can fall from the landing and be injured. Recommend that all work be performed by a qualified contractor.

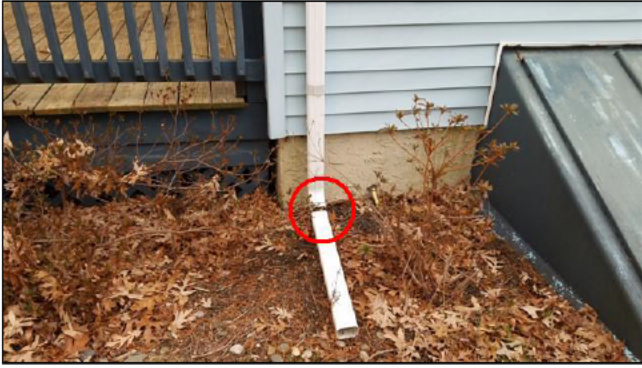
2.4

**2.4 (1)** Downspout is disconnected on rear of home. This should be repaired to allow proper flow of roof drainage away from the foundation perimeter.

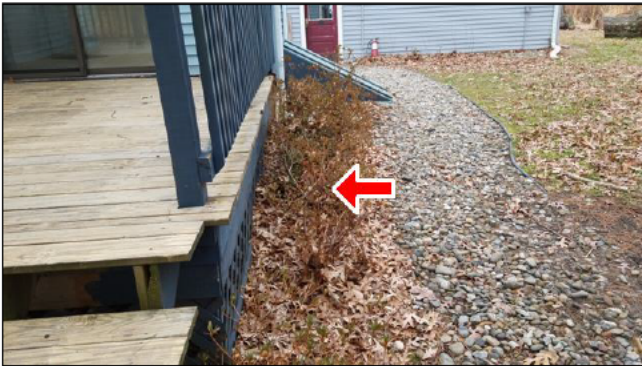
2.4

**2.4 (2)** Shrubs have been constructed near the exterior walls. Water for plants/shrubs will eventually soak into soil and may reach soil supporting the foundation. Excessively high moisture levels in soil supporting the foundation can effect its ability to support the weight of the structure above. The Inspector recommends removal of any shrubbery or plants near the foundation or re-planting with vegetation which has low water requirements.

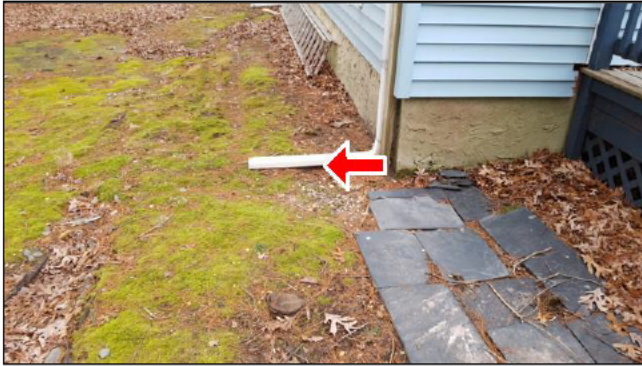
2.4

**2.4 (3)** One or more downspouts discharged roof drainage next to the foundation. This condition can effect the ability of the soil to support the weight of the structure above and can cause damage related to soil/foundation movement. The Inspector recommends the installation of downspout extensions to discharge roof drainage a minimum of 6 feet from the foundation.

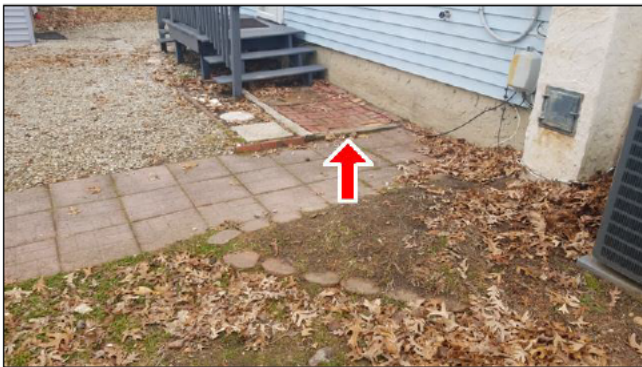
2.4

**2.4 (4)** The concrete walkway at the front of home uneven, and can be a tripping hazard. A fall or injury can occur if not corrected. A qualified person should repair or replace as needed.

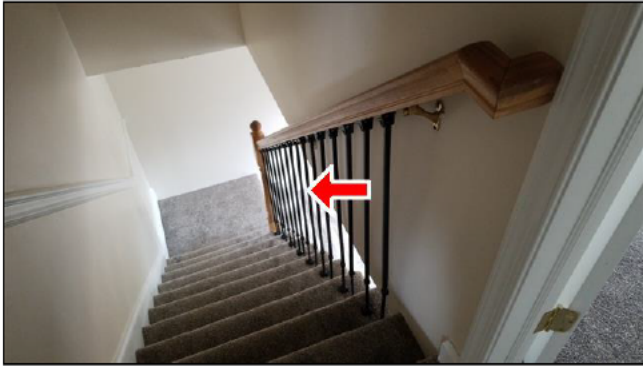
4.3

**4.3** A horizontal guardrail assembly protecting this stairwell had spaces between handrail components that allowed the passage of a 4-inch sphere. To improve child safety, the Inspector recommends altering the guardrail assembly in a manner which will prevent the passage of a 4-inch sphere. This dimension includes areas beneath and to the sides of the guardrail. The Inspector recommends that this condition be updated to meet generally-accepted modern safety standards by a qualified contractor.

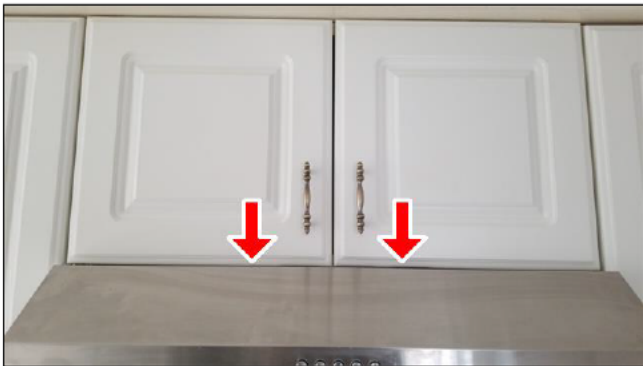
4.4

**4.4** Cabinets above the kitchen exhaust fan rubbed upon opening. These should be adjusted for proper opening and closing. This is for your information.

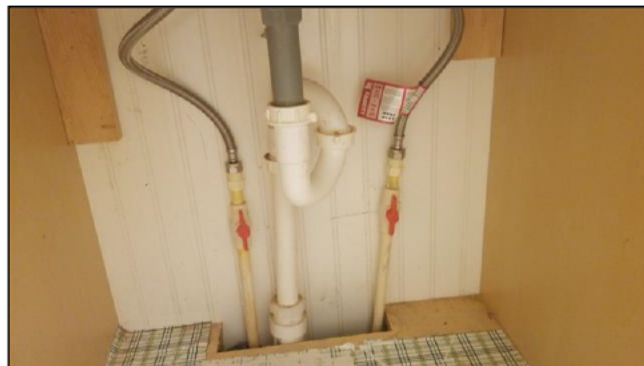
6.0 hall bath

**6.0 (1)** A trap beneath a sink at the shown locations was of a type called an "S-trap". S-traps are no longer allowed to be installed in new construction for safety reasons. A siphon can develop which empties the trap of water; a condition with the potential to allow toxic sewer gas to enter the living space. Although this type of trap may have been commonly considered safe at the time the home was originally constructed, as general knowledge of safe building practices has improved with the passage of time, building standards have changed to reflect current understanding. The Inspector recommends replacement of all such traps in the home by a qualified plumbing contractor.

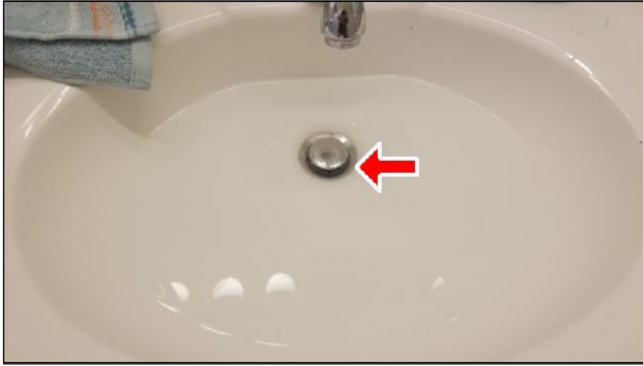
6.0 hall bath

**6.0 (2)** The sink in the powder room was slow to drain. This is typically due to a clogged trap but may also indicate a blockage of the waste pipe. You may wish to have this condition investigated by a licensed plumbing contractor.

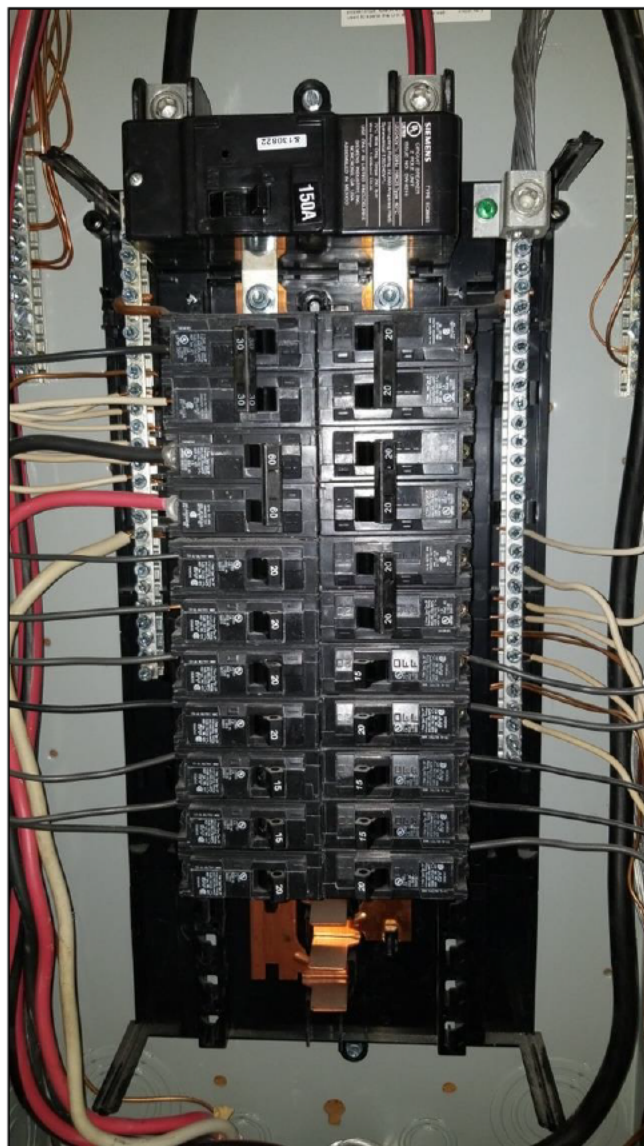
7.1 (2) For the main panel in the master bedroom, I could not locate the ground wire. The ground wire may not be present or could be hidden from view by construction materials. I recommend an electrical contractor verify or install a ground wire.

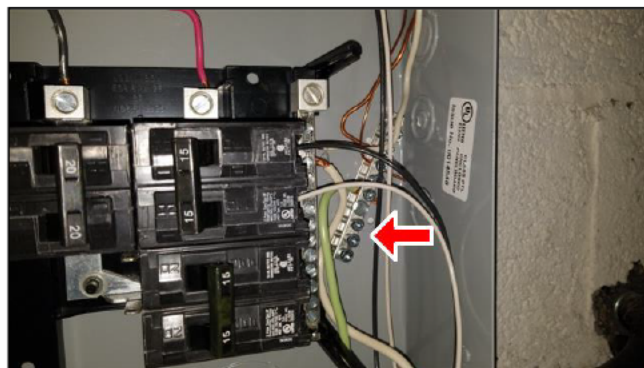
The grounding bar should be properly secured as this is a hazard in its current state. All work should be performed by a licensed electrical contractor.

7.1 Grounding bar should be properly secured to panel

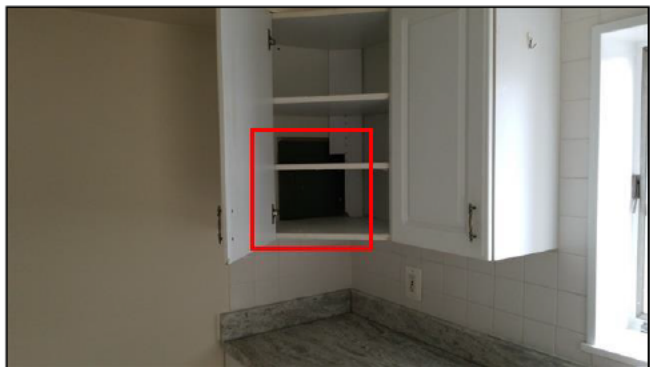
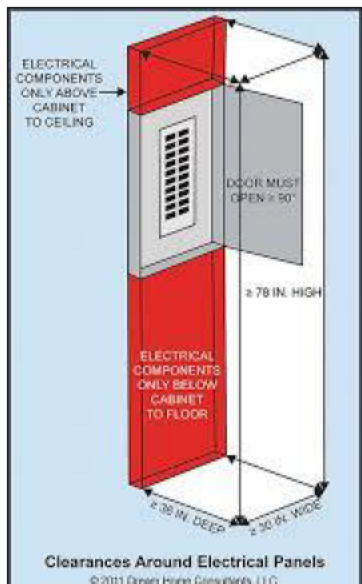
7.1 Panel Access

7.1 (6) There is a subpanel located in the kitchen and behind the kitchen cabinet.

This panel cabinet had inadequate working clearance in front. Modern safety standards require a minimum open space 30 inches in width for a height of 6 feet-6 inches. Minimum clearance in front of the cabinet should be 3 feet. The Inspector recommends correction by a qualified contractor. See illustration for further detail.

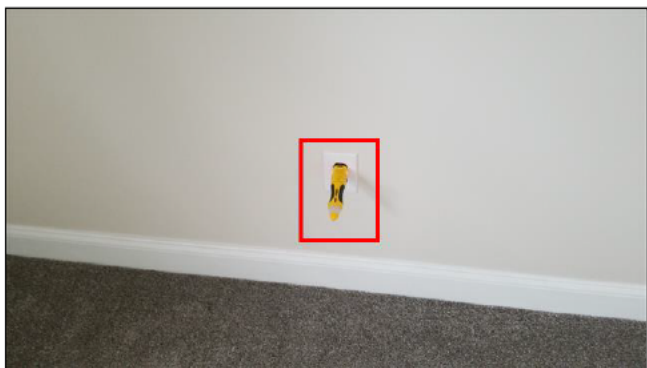
7.3 Front left bedroom Left wall

7.3 (4) An electrical outlet in the shown location had an open neutral that should be corrected by a qualified electrical contractor.

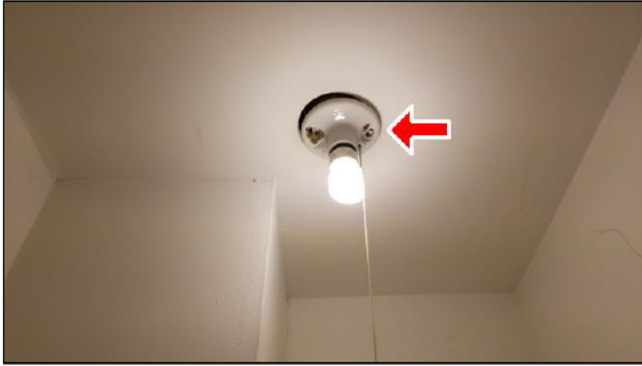
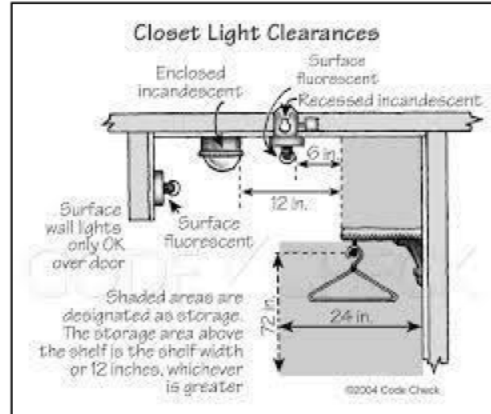
7.3 Front right bedroom

**7.3 (5)** A light in the upstairs bedroom closet was not enclosed. For safety reasons, incandescent light bulbs should be covered as show in the associated illustration. Please have this corrected by a licensed electrician.

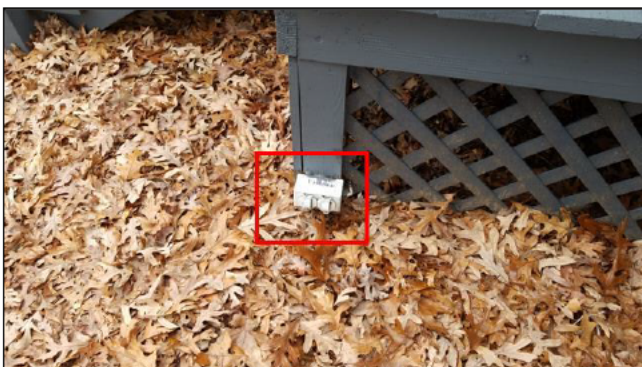
7.4 Front of Home

**7.4 (1)** No Ground Fault Circuit Interrupter (GFCI) breakers were provided at the shown locations at the time of inspection.

All work should be performed by a licensed electrician.

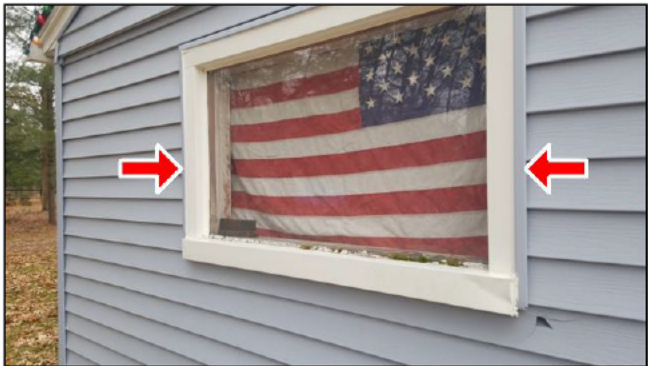
2.2 garage&#160;

**2.2** Windows around the exterior of the home were caulked. Caulking usually breaks down over time and can result in moisture intrusion affecting the underlying structure and interior. It is recommended that all windows be maintained on a periodic basis to prevent deterioration. This is a maintenance issue and is for your information.

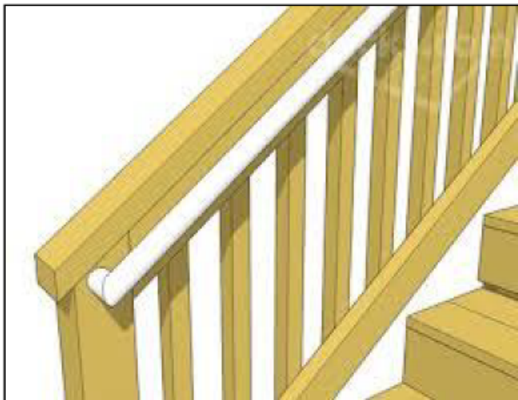
2.3 Handrail

(2) The inspector recommends installation of both a guardrail and graspable handrail at the Rear Deck Steps. This is considered a safety hazard as someone can fall from the landing and be injured. Recommend that all work be performed by a qualified contractor.

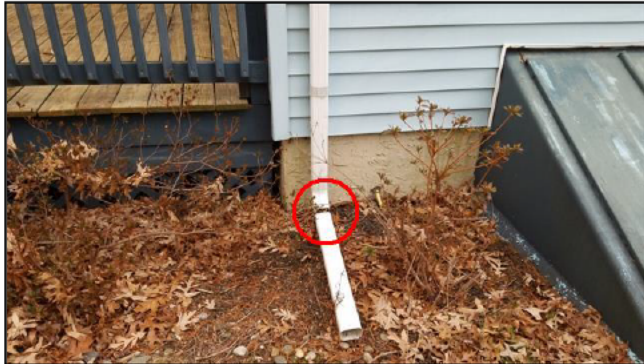
2.4

(1) Downspout is disconnected on rear of home. This should be repaired to allow proper flow of roof drainage away from the foundation perimeter.

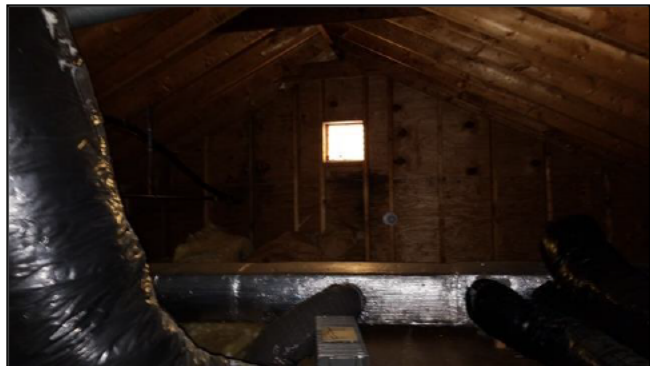
5.5

Gable end sheathing had areas of discoloration near the eaves. This may be due to a prior or active leak or the discoloration may be due to condensation. The inspector recommends that the sheathing be further evaluated by a qualified contractor who can recommend a solution to avoid further deterioration.

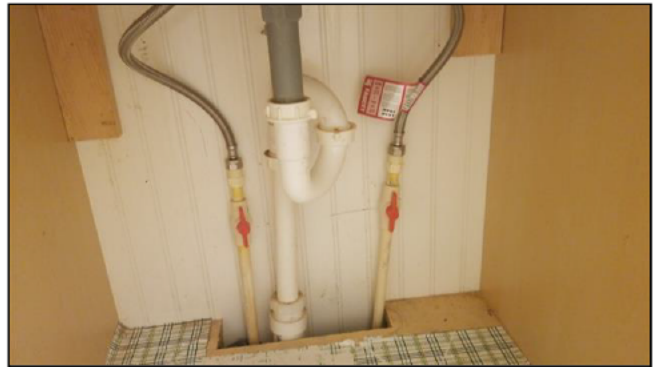
6.0 hall bath

(1) A trap beneath a sink at the shown locations was of a type called an "S-trap". S-traps are no longer allowed to be installed in new construction for safety reasons. A siphon can develop which empties the trap of water; a condition with the potential to allow toxic sewer gas to enter the living space. Although this type of trap may have been commonly considered safe at the time the home was originally constructed, as general knowledge of safe building practices has improved with the passage of time, building standards have changed to reflect current understanding. The Inspector recommends replacement of all such traps in the home by a qualified plumbing contractor.

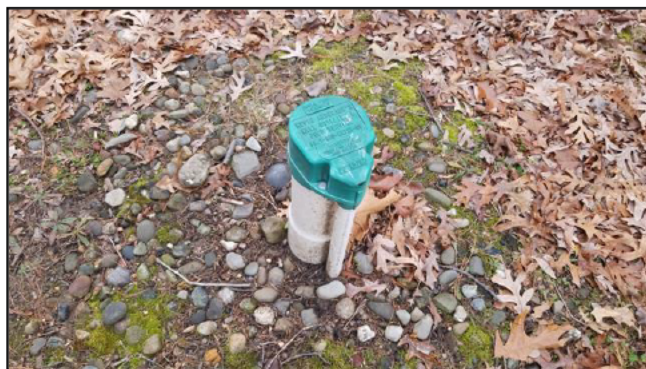
6.1

(2) The home is supplied by well water. This is for your information

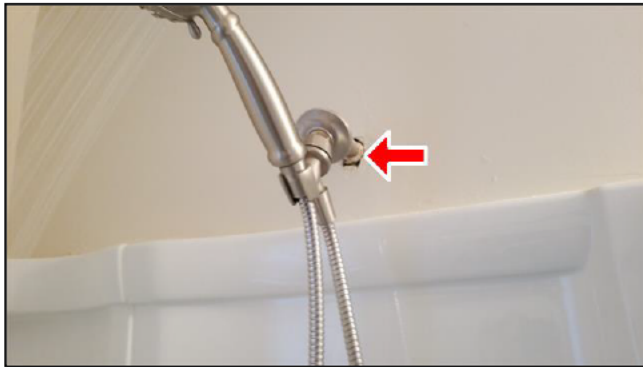
6.1

(4) Seal escutcheon plate in master bedroom shower to prevent moisture intrusion. All work should be performed by a licensed plumber.

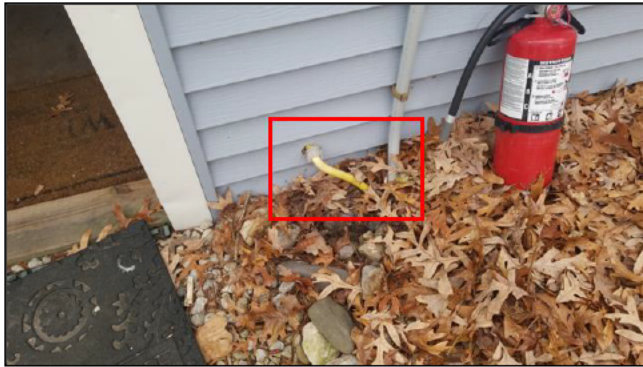
6.4

There is an exposed gas line on the exterior of the garage. It appears that this supplied gas to the previously installed garage heater. It does not appear that this line is in use but I am not able to determine. Recommend further evaluation by a licensed plumber to ensure that this line is properly abandoned.

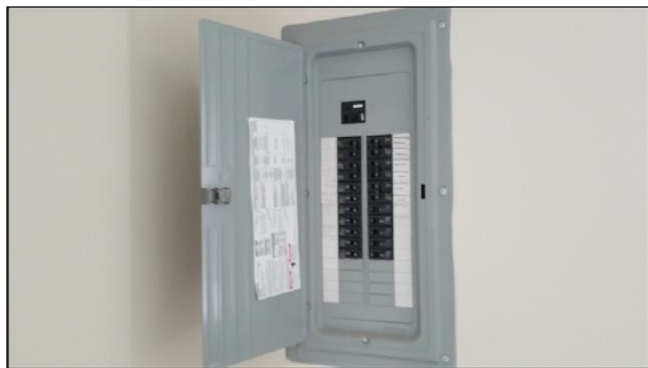
7.1

(1) The main distribution panel is located in the master bedroom with a capacity of 150 amps.

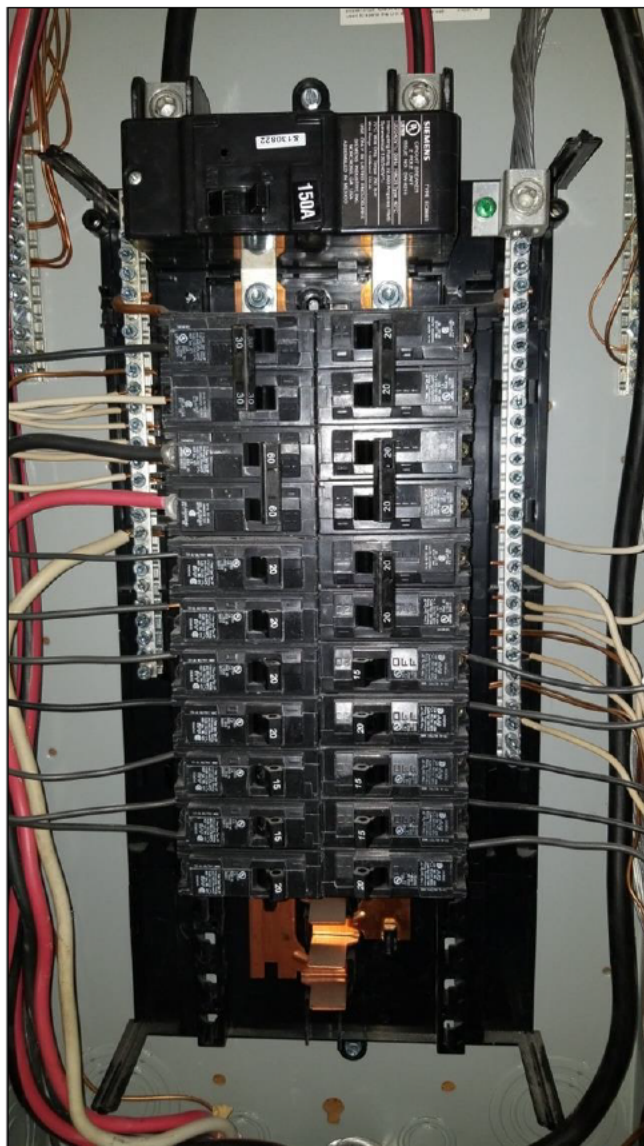
7.1

(2) For the main panel in the master bedroom, I could not locate the ground wire. The ground wire may not be present or could be hidden from view by construction materials. I recommend an electrical contractor verify or install a ground wire.

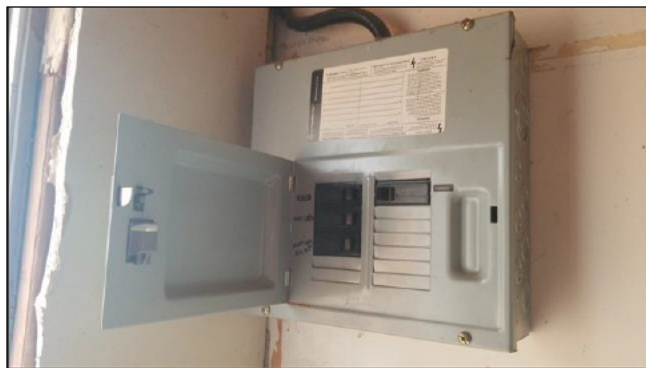
7.1

(3) There is a GE sub panel located in the garage . This is for your information. The service disconnect for this sub panel appears to be in the kitchen sub panel behind the cabinet to the left of sink.

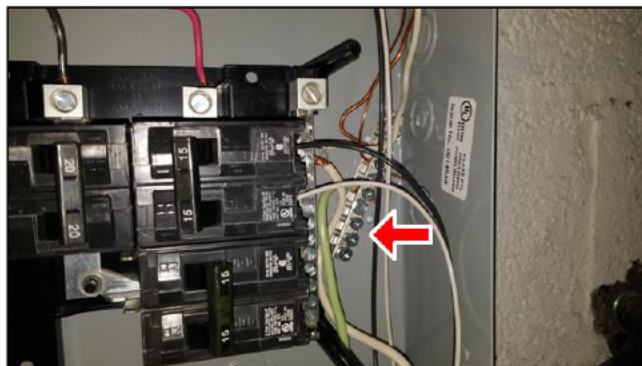
The grounding bar should be properly secured as this is a hazard in its current state. All work should be performed by a licensed electrical contractor.

7.1 Grounding bar should be properly secured to panel

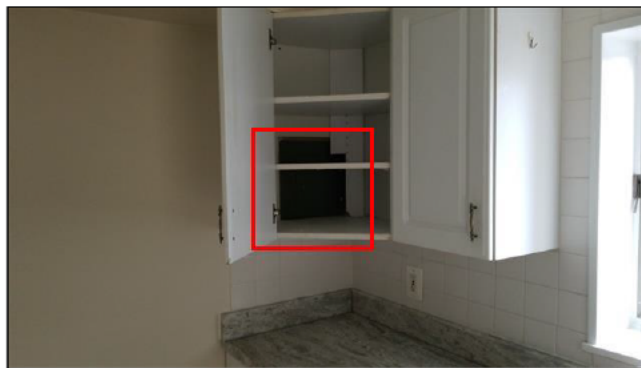
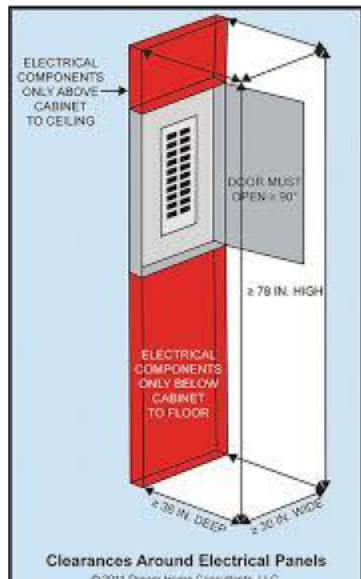
7.1 Panel Access

(6) There is a subpanel located in the kitchen and behind the kitchen cabinet.

This panel cabinet had inadequate working clearance in front. Modern safety standards require a minimum open space 30 inches in width for a height of 6 feet-6 inches. Minimum clearance in front of the cabinet should be 3 feet. The Inspector recommends correction by a qualified contractor. See illustration for further detail.

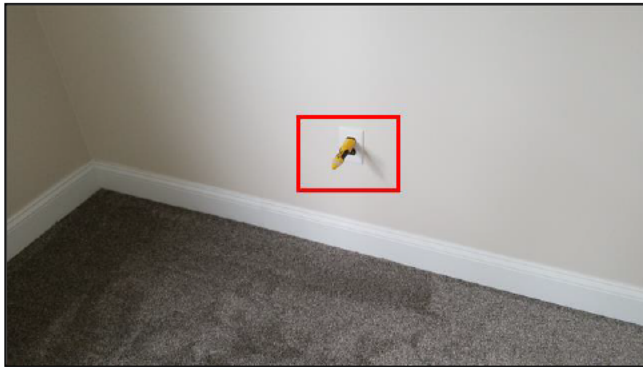
(3) Shown outlets were not working at the time of inspection. Further inspection is needed by a licensed electrical contractor. A licensed electrical contractor should perform repairs that involve wiring.

7.3 Rear master bedroom rear wall

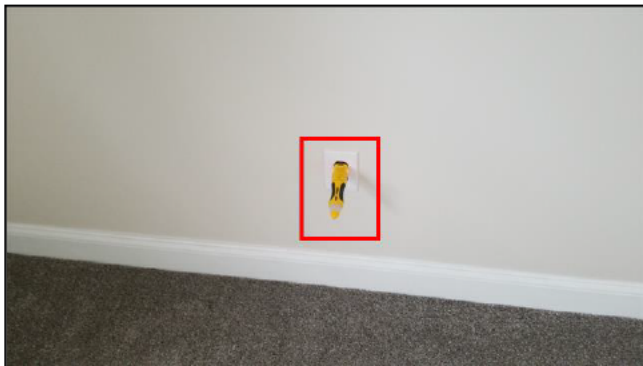
(4) An electrical outlet in the shown location had an open neutral that should be corrected by a qualified electrical contractor.

7.3 Front left bedroom Left wall

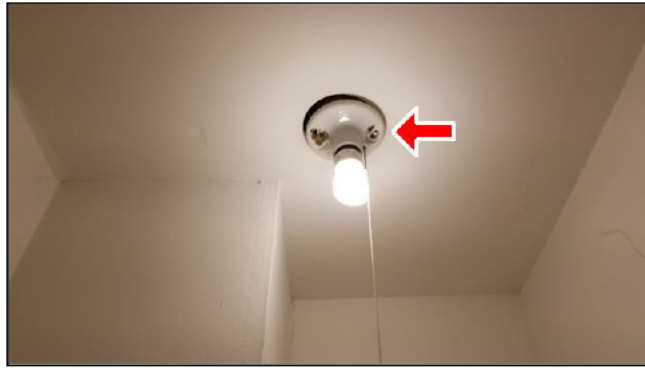
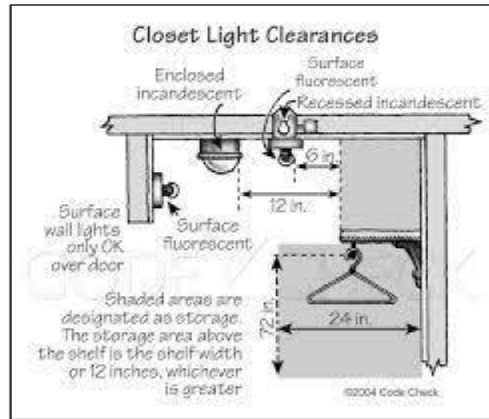
(5) A light in the upstairs bedroom closet was not enclosed. For safety reasons, incandescent light bulbs should be covered as show in the associated illustration. Please have this corrected by a licensed electrician.

7.3 Front right bedroom

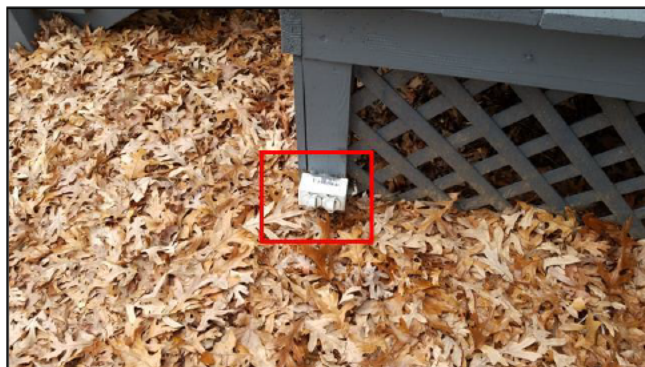
7.4 Front of Home

- Bathrooms
- The home exterior
- Garages
- Crawlspace (at or below grade)
- Unfinished basements
- Kitchens

All work should be performed by a licensed electrician.

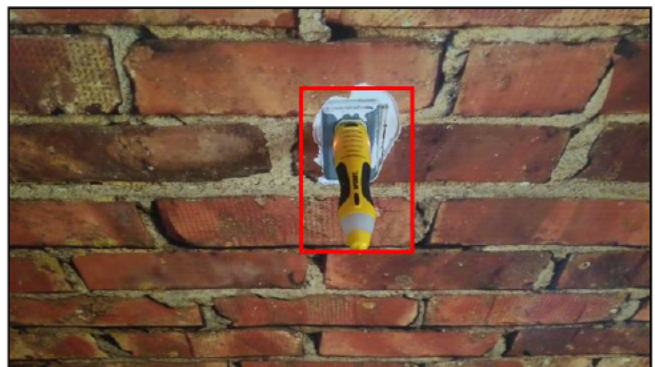
7.4 Garage

(2) Multiple Garage receptacles have an open ground. This is a safety hazard and can cause shock or electrocution. Please have this corrected by a licensed electrician.

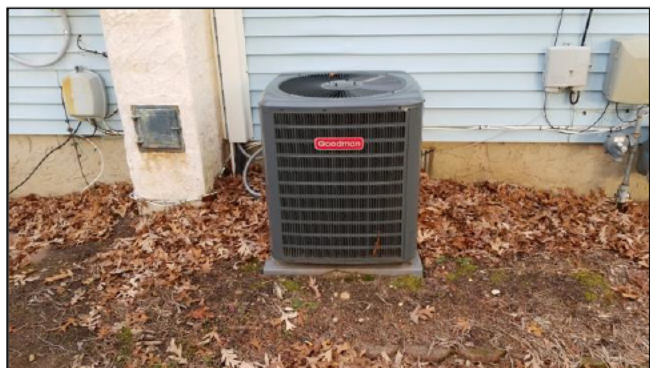
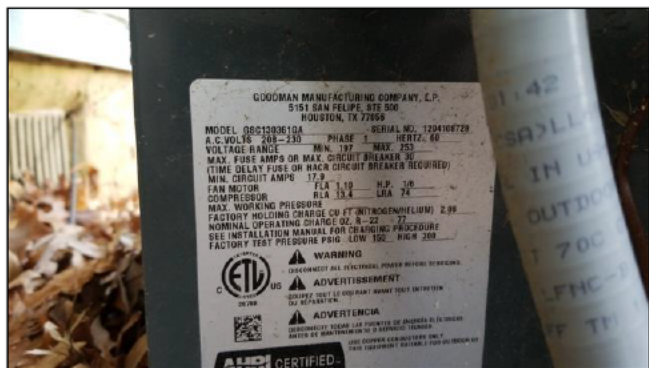
8.8

(1) Goodman air condenser manufactured in approximately 2012.
